ARBORICULTURAL INSPECTION REPORT

BUCHAN CAVES RESERVE, NORTH ARM TREE INSPECTION SURVEY, 2023

OCTOBER 2023 (UPDATED 9/05/2024)

Prepared by Stephen Fitzgerald
for:
Parks Victoria

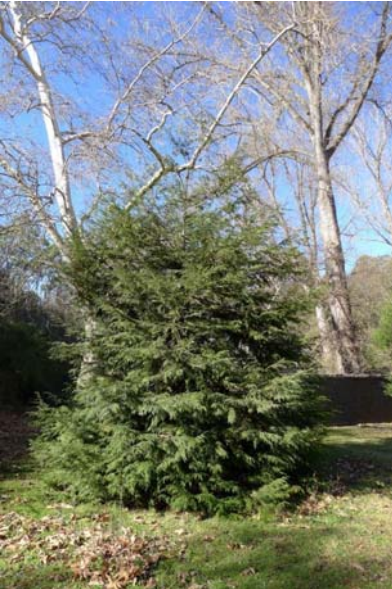
Comments: [JH 2022: N/A] TPZ Encroach: 0%. SRZ Encroached?: No

Assessment: No impact

Image 1 from north-west: Tree 2301 smaller tree in foreground

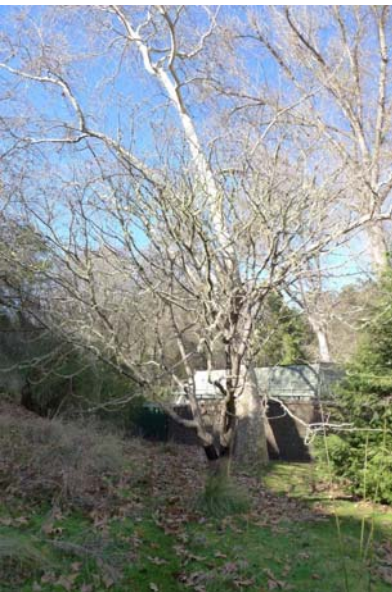
No: 2302

Comments: Stem is within excavation area, [JH 2022: N/A] TPZ Encroach: 77%. SRZ Encroached?: Yes

Assessment: Lost

Image 1 from north-west: Tree 2302 smaller tree in foreground

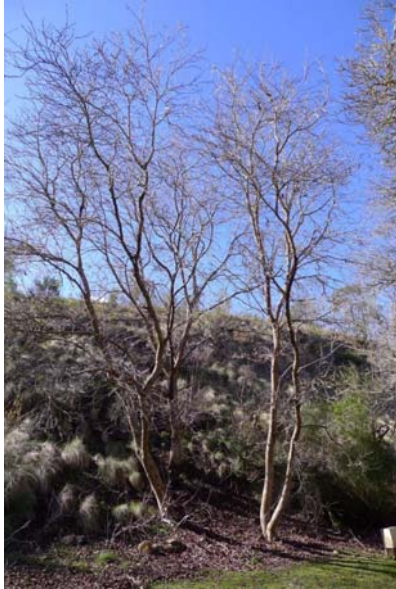
Comments: Stem is within excavation area, Possibly self sown, [JH 2022: N/A] TPZ Encroach: 55%. SRZ Encroached?: Yes

Assessment: Lost

Image 1 from west: Tree 2305 and trees 2305 and 2306

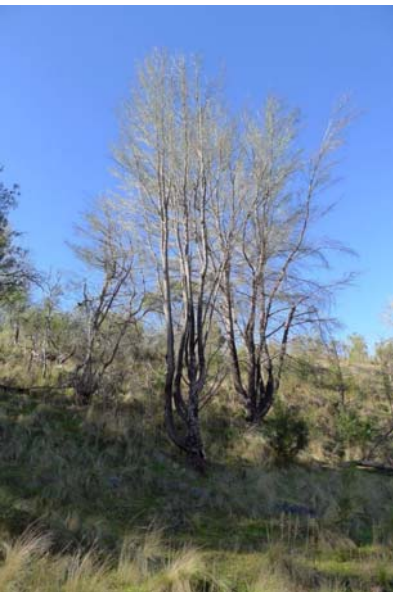
No: 2308 **Species:** *Pinus halepensis* **Common Name:** Aleppo Pine

Comments: Fire damage, [JH 2022: N/A], Reasons for tree removal (2023): Dead TPZ Encroach: 0%. SRZ Encroached?: No

Image 1 from south-west: Tree 2308

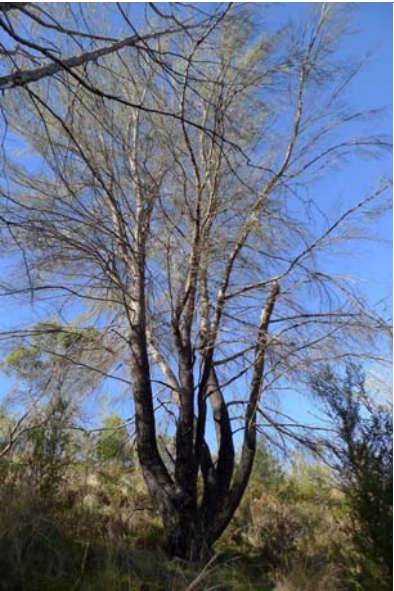
No: 2309

Comments: Fire damage, [JH 2022: N/A], Reasons for tree removal (2023): Dead TPZ Encroach: 0%. SRZ Encroached?: No

Image 1 from south-west: Tree 2309

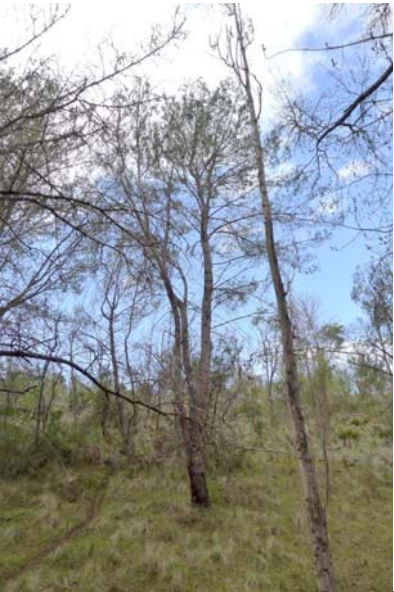
No: 2310

Comments: Species/cultivar identification required, Fire damage, [JH 2022: N/A] TPZ Encroach: 0%. SRZ Encroached?: No

Image 1 from south-west: Tree 2310

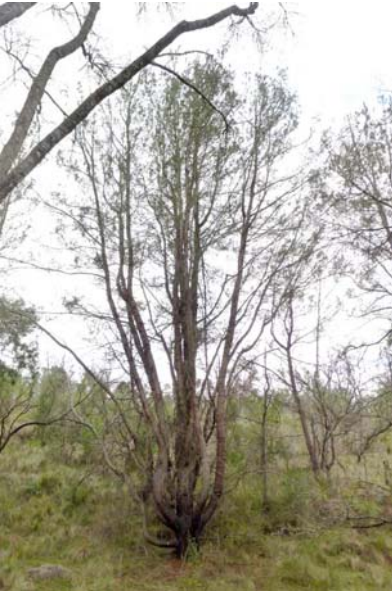
No: 2311

Comments: Fire damage, [JH 2022: N/A] TPZ Encroach: 8%. SRZ Encroached?: No

Assessment: Minor impact

Image 1 from south-west: Tree 2311

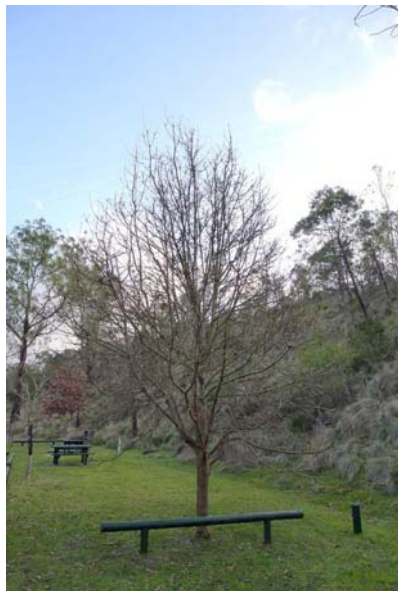
No: 2315 **Species:** *Fraxinus excelsior 'Aurea'*

Comments: Stem is within excavation area, [JH 2022: N/A] TPZ Encroach: 74%. SRZ Encroached?: Yes

Assessment: Lost

Image 1 from south-west: Tree 2315

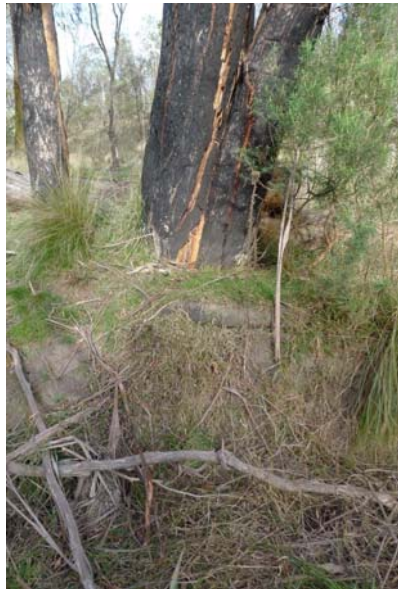
No: 2328 **Species:** *Eucalyptus viminalis* **Common Name:** Manna Gum

Comments: Appears to be recovering health after fire damage, Stem within excavation area. Erosion bank close to east side of stem, [JH 2022: N/A] TPZ Encroach: 0%. SRZ Encroached?: No

Image 1 from north-east: Tree 2328 base of stem near erosion

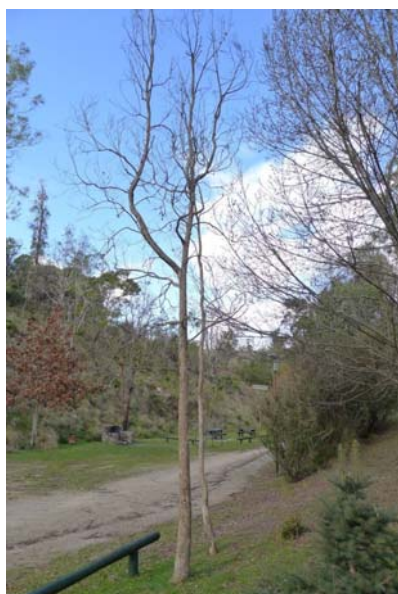
No: 2335 **Species:** *Eucalyptus melliodora*

Comments: Tree appears almost dead but still has buds and a few leaves. Tree could possibly recover if possum protection is done very soon, [JH 2022: N/A] TPZ Encroach: 0%. SRZ Encroached?: No

Image 1 from north: Tree 2335 right stem, 2336 left stem

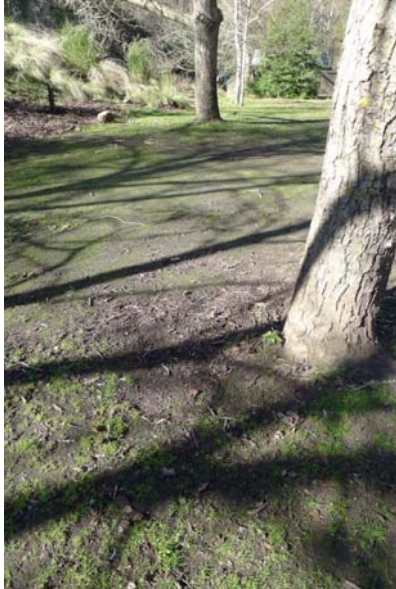
Assessment: Moderate to high impact

Image 1 from north-west: Tree 540 swale route - no buttressing on north east side (works side)

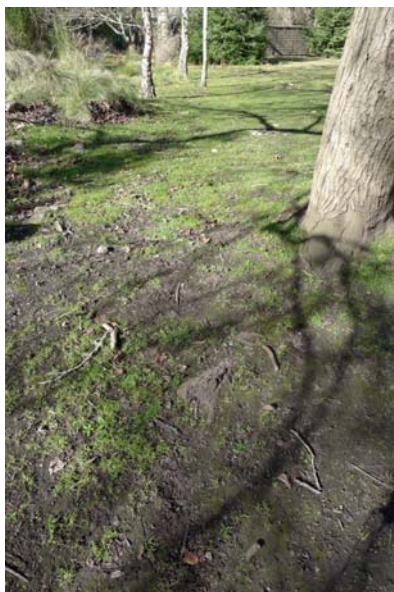
Image 2 from north-west: Tree 541 swale route - surface root and buttress heading north

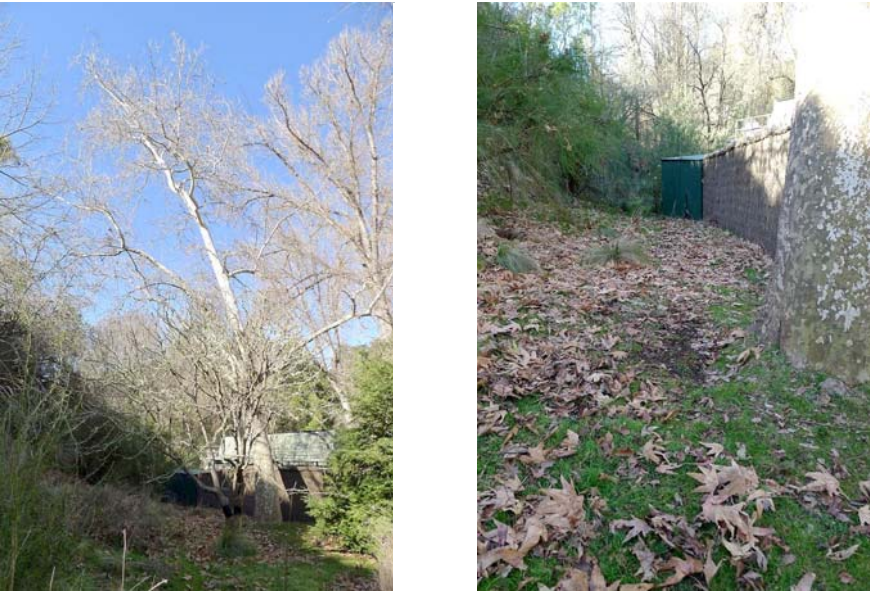
No: 548

Tree #548 is a mature Oriental Plane near the water treatment plant. While the impact analysis suggests the tree is likely to be lost it is recommended that efforts be undertaken to achieve the functional design outcomes of the swale while minimising damage to the tree's root system. This will require careful hand digging and/or NDD (non-destructive digging using air or water) under the

Assessment: Lost

Image 1 from north-west: Tree 548

Image 2 from north-west: Tree 548 proposed swale route

supervision of an arborist during the works. Following or during the works the arborist will determine if the tree can be safely retained (or possibly recommend further investigation such as a tree stability test if significant roots were severed).

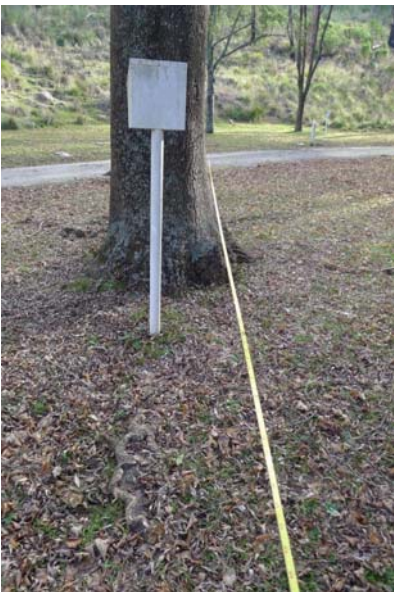
Image 2 from east: Tree 563 swale route - surface roots

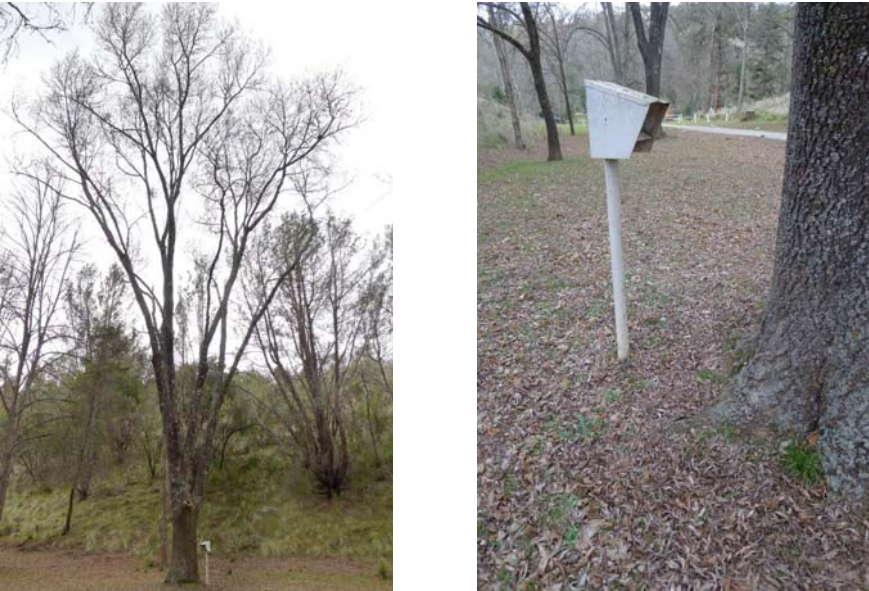
No: 567

Assessment: Lost

Image 1 from south-west: Tree 567

Image 2 from north: Tree 567 swale route - one root flare in direction of works

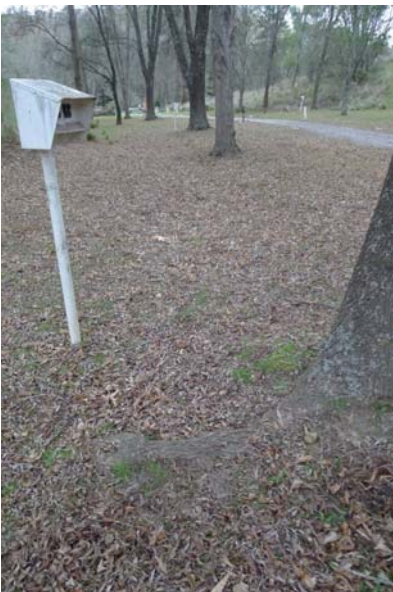
Image 2 from north: Tree 571 swale route - surface roots

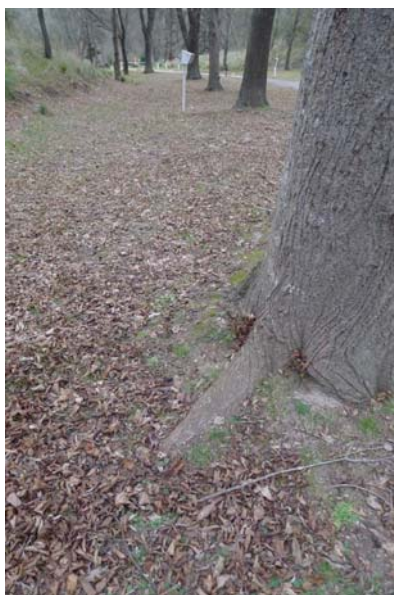
Image 2 from north: Tree 574 swale route - surface roots to 1m of stem on east side

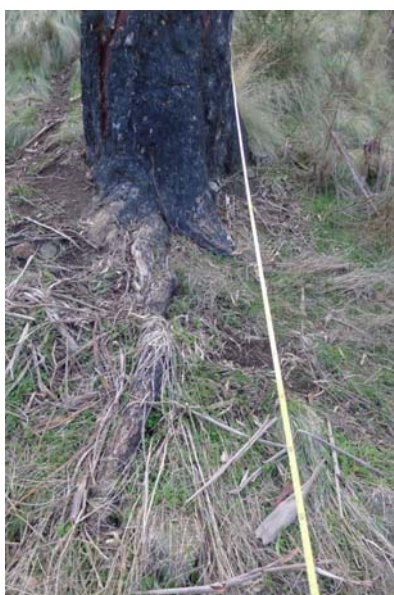
Image 2 from west: Tree 594 surface roots to 3.4m of stem centre

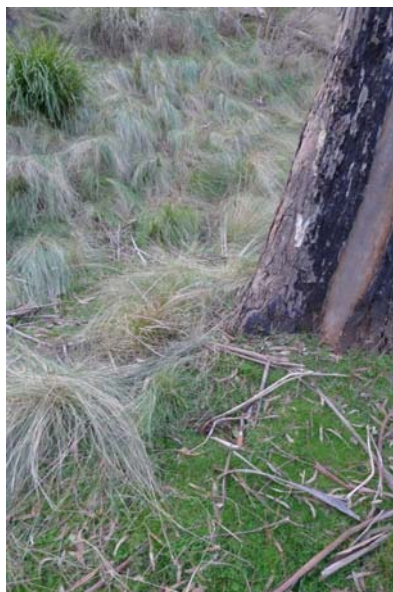
Image 2 from north-west: Tree 623 root plate heave on north east side has stabilised
