Proposal to Remove stairway
ATHENAEUM BUILDING
28-36 OCEAN BEACH ROAD SORRENTO
Report on 'Reasonable or Economic Use'

Prepared for Shatter Pty Ltd
September 2024

Prepared by Rodger Gibbins
Urban Economist and Planner

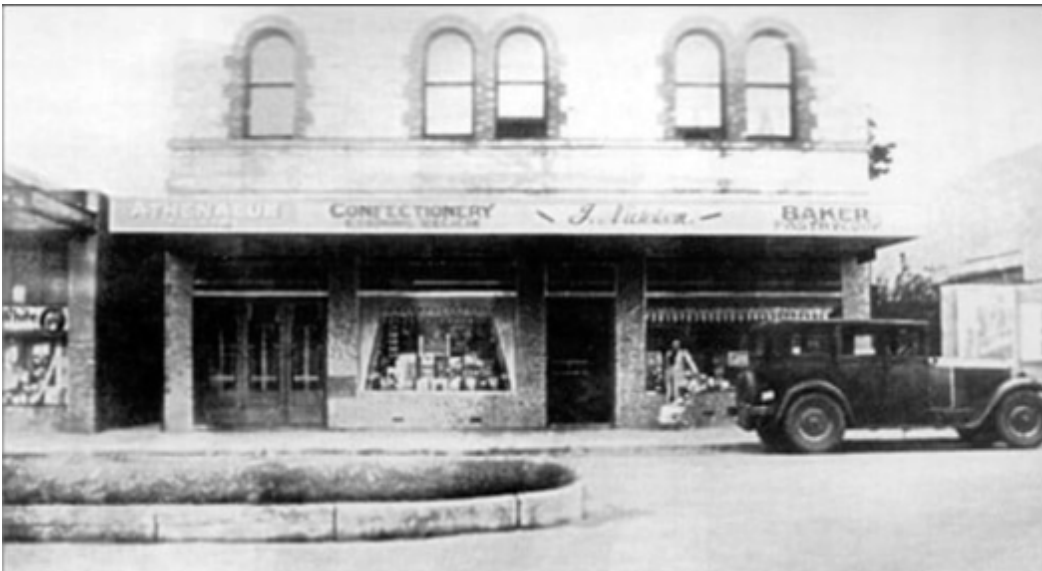
FIGURE 3- THE BUILDING CIRCA 1920

In November 1925 it was reported that 'extensive alterations' to the Athenaeum were to shortly commence. The whole of the interior was to be renovated. The works undertaken at this time are thought to have included removal of the proscenium wall and a reduction in the depth of the stage to allow for increased seating capacity. The bio-box was rebuilt in 1931, necessitating the relocation of the main auditorium entrance further west. The shopfronts had been rebuilt by this time with a cantilevered awning in place of the original cast iron verandah (Figure 3).
