BUSHFIRE ATTACK LEVEL ASSESSMENT

Proposal: Accommodation Cabins

Address: Buchan Caves Reserve
Caves Road, Buchan

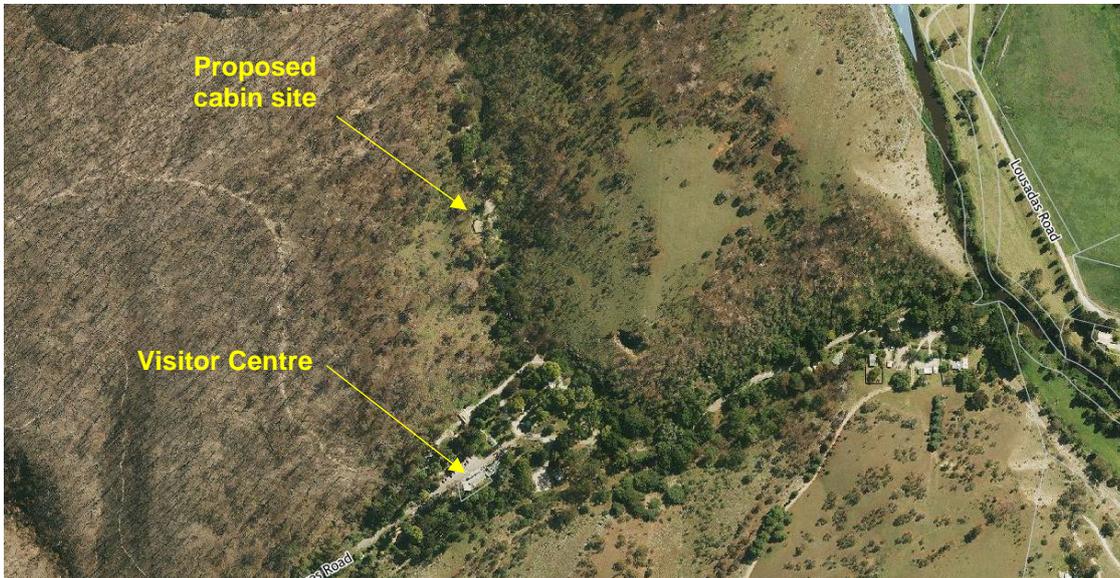
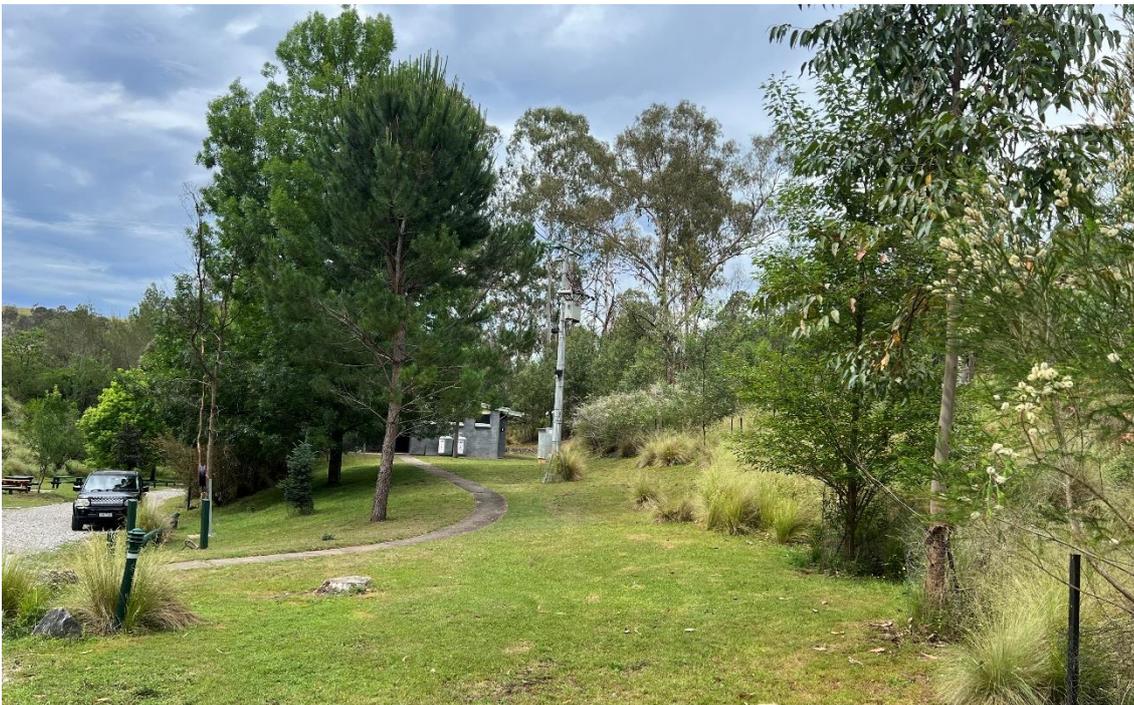
A site for the development of cabins has been identified at the northern end of the campground, approximately 320 metres north from the Visitor Centre. The cabins are proposed to be constructed on the north side of an existing brick toilet and laundry building.

View south of proposed cabin site with existing toilet/laundry building in background

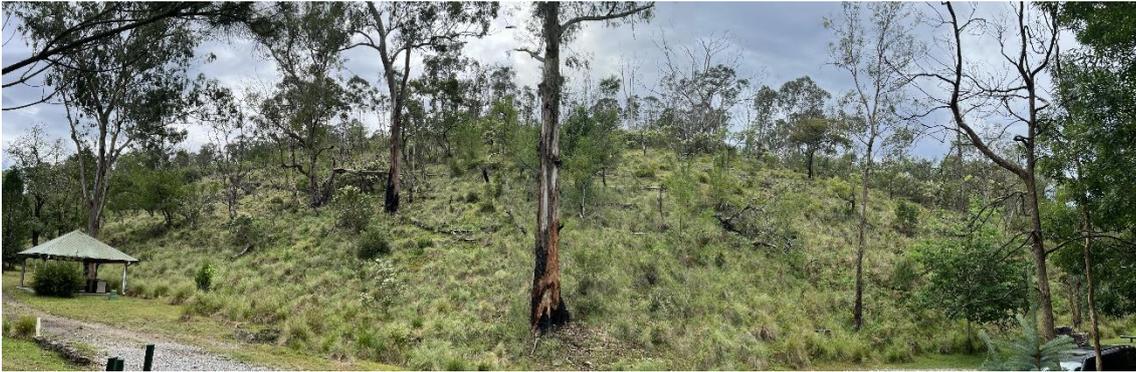
Vegetation observed from the subject site within the 100m assessment area included open native grasses on steep slopes to the east. Some mature trees are present, however the extent of canopy cover by mature trees is sparse and appears to be less than 10 percent coverage throughout the eastern aspect.

Vegetation on the eastern aspect is considered to constitute *Grassland* as defined under Table 2.3 of AS 3959.2018.

View east from site

The proposed cabins currently achieve a separation distance of 15 metres from vegetation on the eastern aspect. A separation distance on a flat slope enables construction of the cabins to a Bushfire Attack Level of 19 (BAL-19).

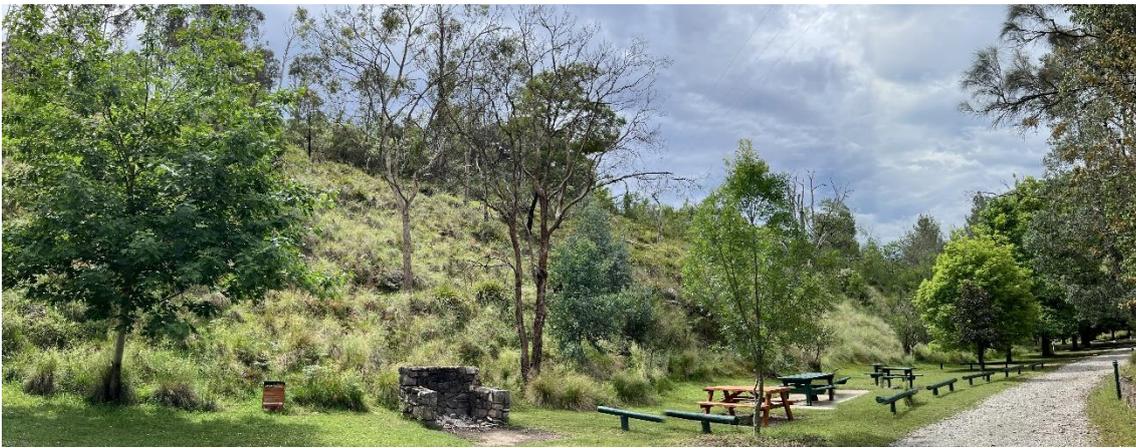
View south-east from in front of site side of site

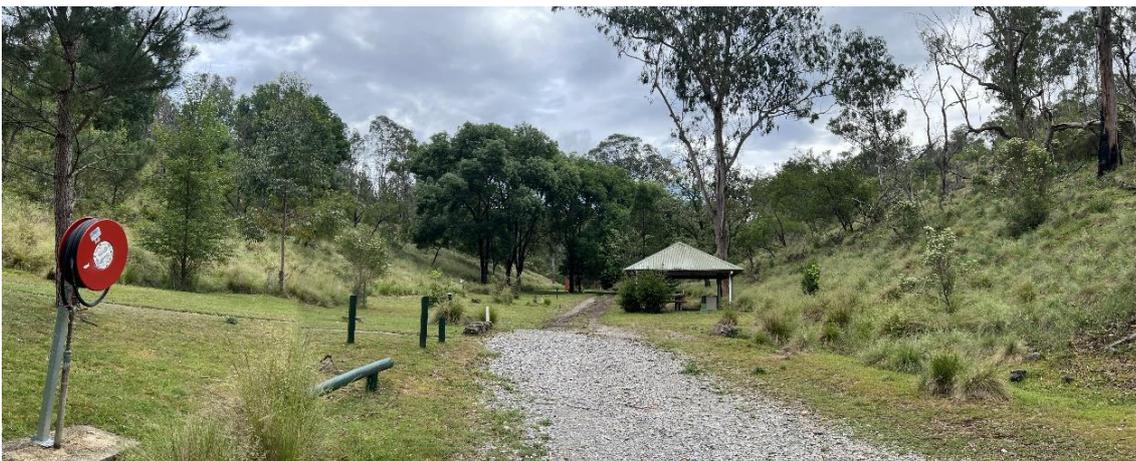
Established camping sites, picnic areas and barbecue shelters contain scattered exotic trees and short cropped (mown) grass, with no understorey present. Vegetation in these areas is considered excludable pursuant to the provisions at Clause 2.2.3.2 of AS3959.2018.

View north from the subject site

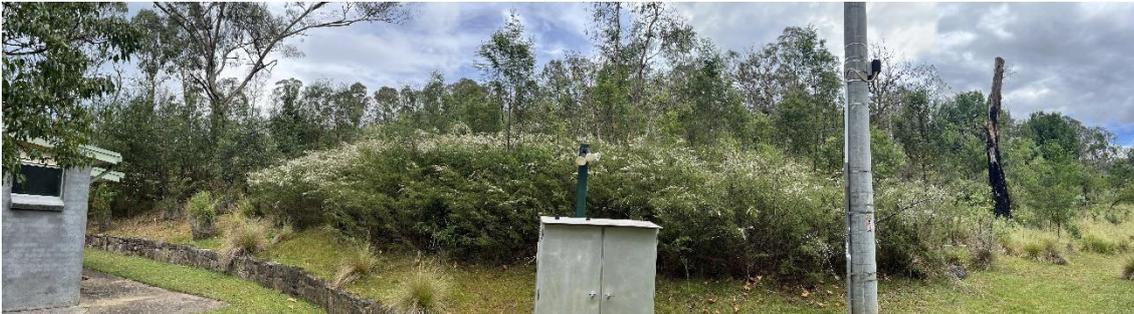
A variety of plant species were observed on the western aspect of the subject site that included mature trees, native shrubs, native grasses and native vegetation regrowth. This aspect contains considerably more regrowth, with juvenile trees consisting of acacia (wattle) and eucalyptus species.

The regenerating trees are quite young which is common to see after a bushfire event. The height of the regenerating vegetation currently appears to have the characteristics of *Scrub*, however if retained and allowed to mature the regrowth on the western aspect would constitute *Forest*, as defined under Table 2.3 of AS 3959.2018.

The BAL rating for the cabins can be reduced from BAL-FZ should the separation distance from classifiable vegetation be increased, with any remaining vegetation contained within the separation distance managed to a low fuel condition so as to no longer be classifiable vegetation.

The following table prescribes the separation distances to be achieved on the west side (upslope) of the proposed accommodation cabins with the corresponding BAL rating.

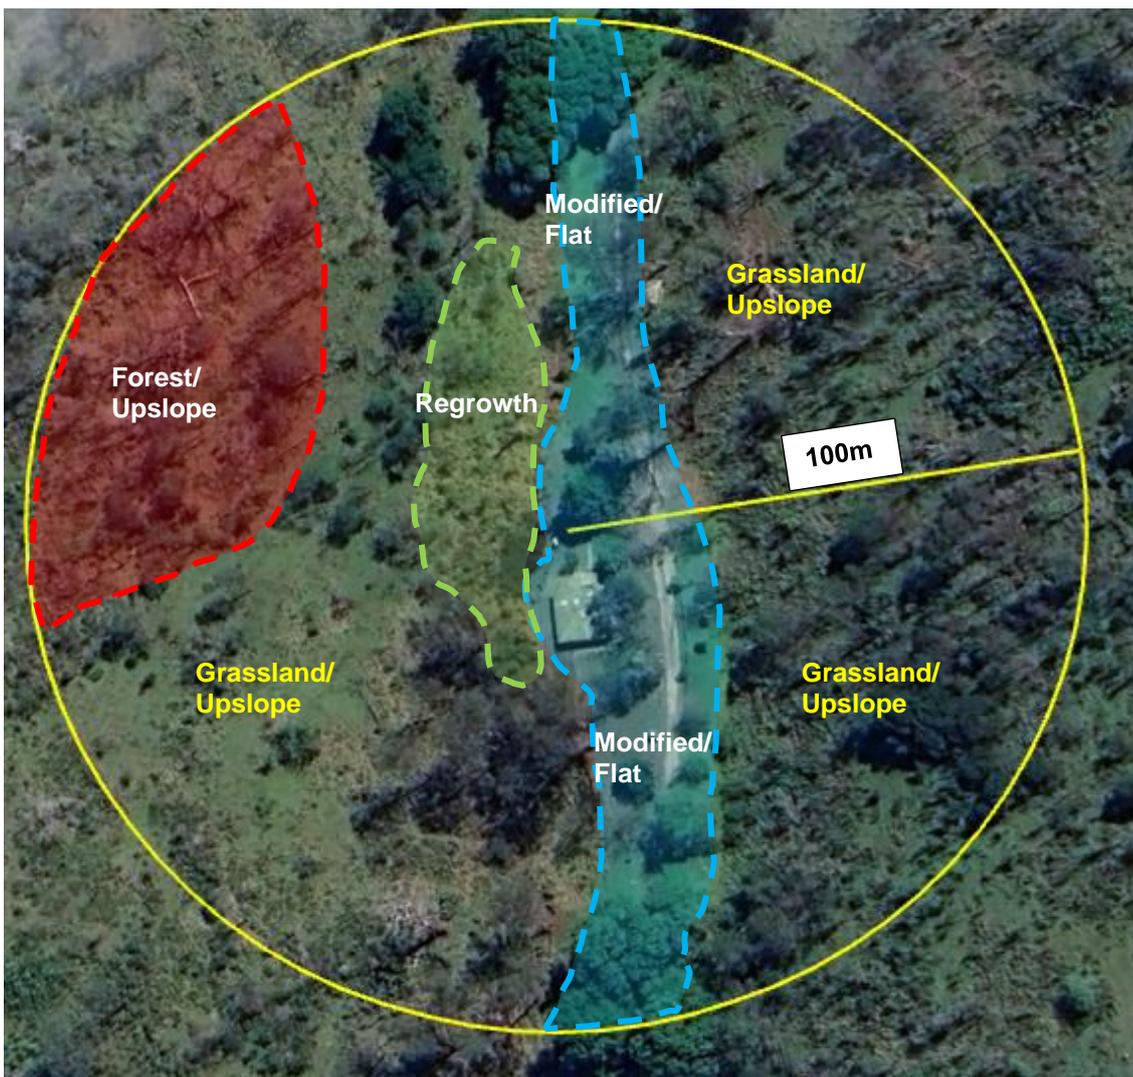
A review of aerial imagery indicates *Forest* vegetation remains on the upper slope of the western aspect, with the appearance of *Grassland* vegetation on the middle slope.
