ARBORICULTURAL INSPECTION REPORT

BUCHAN CAVES RESERVE, NORTH ARM TREE INSPECTION SURVEY, 2023

OCTOBER 2023 (UPDATED 9/05/2024)

Prepared by Stephen Fitzgerald
for:
Parks Victoria

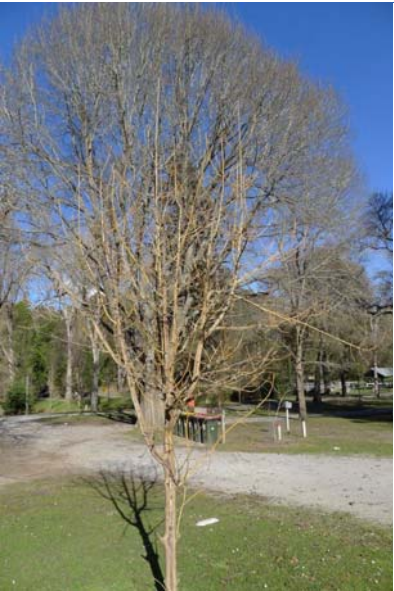
Image 1 from north-west: Tree 2307

Defects: Sun scald, General poor form

Comments: [JH 2022: N/A], Reasons for tree removal (2023): Decline of landscape value TPZ Encroach: 0%. SRZ Encroached?: No

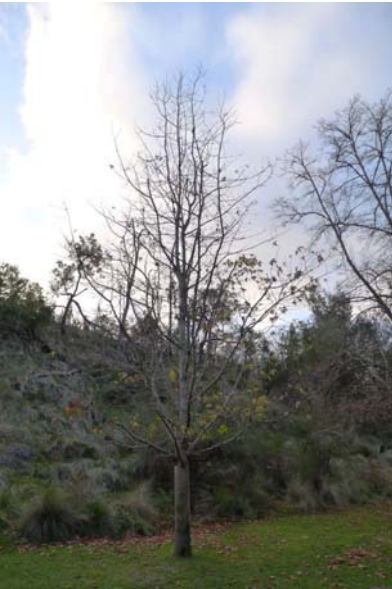
Image 1 from north-west: Tree 2314

Defects: Minor or none noticed

Comments: Stem is within excavation area, [JH 2022: N/A] TPZ Encroach: 68%. SRZ Encroached?: Yes

Assessment: Lost

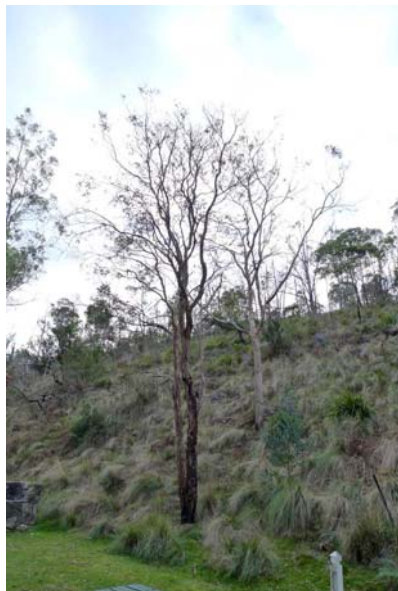
Image 1 from south-west: Tree 2320

Defects: Fire damage, Bifurcation defects of stem

Comments: [JH 2022: N/A] TPZ Encroach: 38%. SRZ Encroached?: Yes

Assessment: Lost

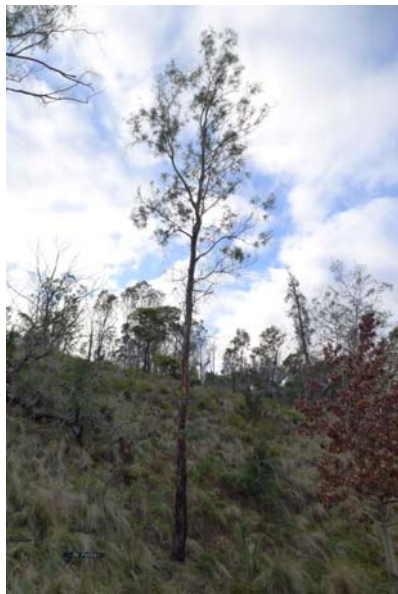
Image 1 from west: Tree 2322

Defects: Fire damage (slight)

Comments: [JH 2022: N/A] TPZ Encroach: 17%. SRZ Encroached?: No

Assessment: Moderate impact

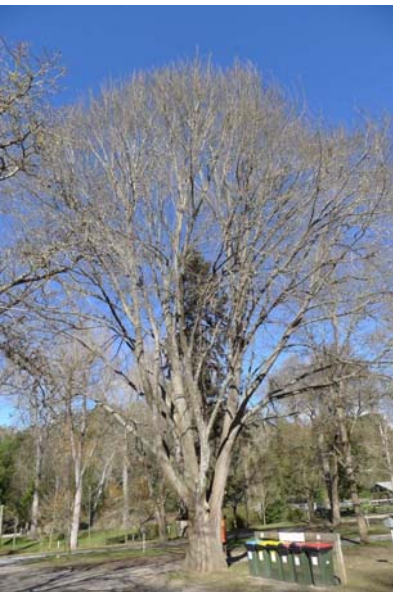
Image 1 from north: Tree 167

Defects: Bifurcation defects of stem

Comments: 6 dynamic braces installed- check age and inspection history, [JH 2022: N/A] TPZ Encroach: 1%. SRZ Encroached?: No

Assessment: Minor impact

Maintenance Actions: Medium Priority Actions: Check & adjust or replace cable-bracing

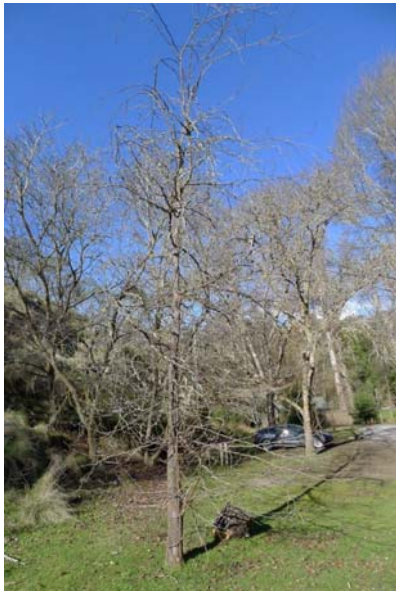
Image 1 from north-west: Tree 538

Defects: Sun scald, General poor form

Comments: Stem is within excavation area, [JH 2022: Remove], Reasons for tree removal (2023): Decline of landscape value TPZ Encroach: 97%. SRZ Encroached?: Yes

Assessment: Lost

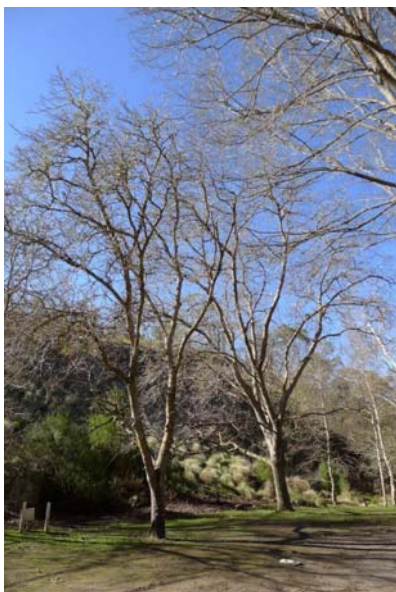
Image 1 from west: Tree 541 background right, tree 540 left

Defects: Minor or none noticed

Comments: Stem is within excavation area, [JH 2022: N/A] TPZ Encroach: 55%. SRZ Encroached?: Yes

Assessment: Lost

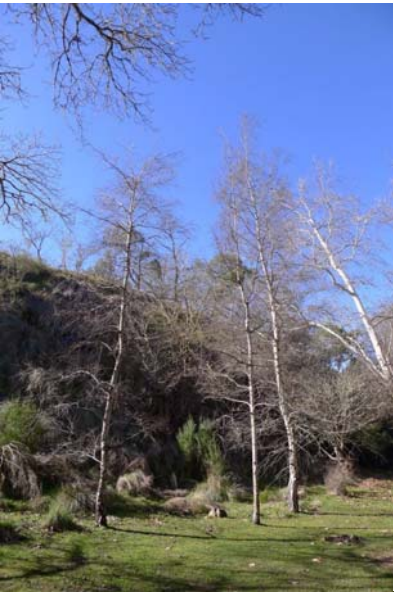
Image 1 from north-west: Tree 545
(background), tree 544 centre, tree 543 left

Comments: Stem is within excavation area, [JH 2022: N/A] TPZ Encroach: 62%. SRZ Encroached?: Yes

Assessment: Lost

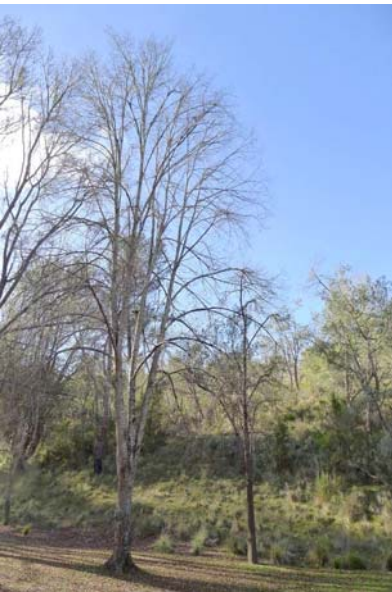
Image 1 from south-west: Tree 561 background right, tree 562 left

Comments: Stem is within excavation area, [JH 2022: Remove] TPZ Encroach: 92%. SRZ Encroached?: Yes

Assessment: Lost

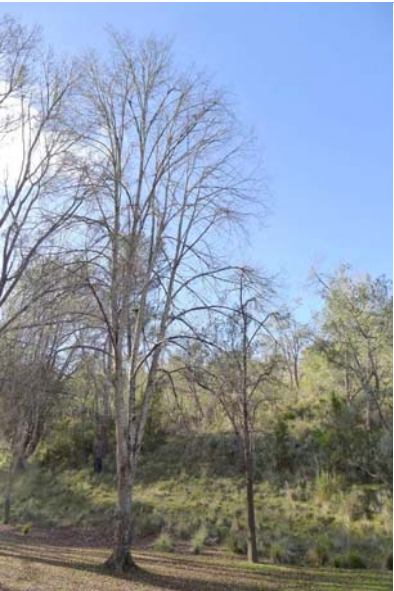
Image 1 from south-west: Tree 562 left taller tree

Defects: Bifurcation defects of stem

Comments: Stem is within excavation area, [JH 2022: N/A] TPZ Encroach: 52%. SRZ Encroached?: Yes

Assessment: Lost

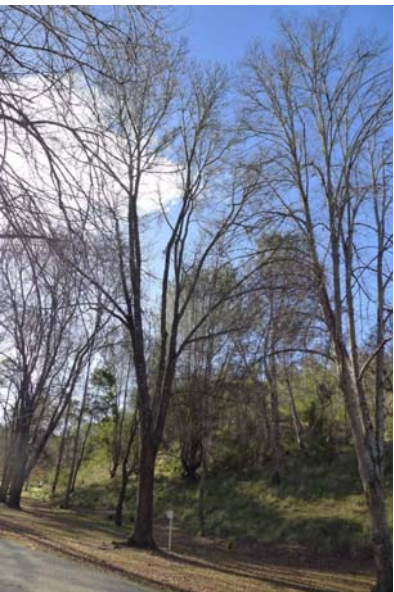
Image 1 from south-west: Tree 563 left

Comments: Large root buttresses away from works but some surface roots 2.7m east of stem centre, Stem very close to excavation area, [JH 2022: N/A] TPZ Encroach: 42%. SRZ Encroached?: Yes

Assessment: Lost

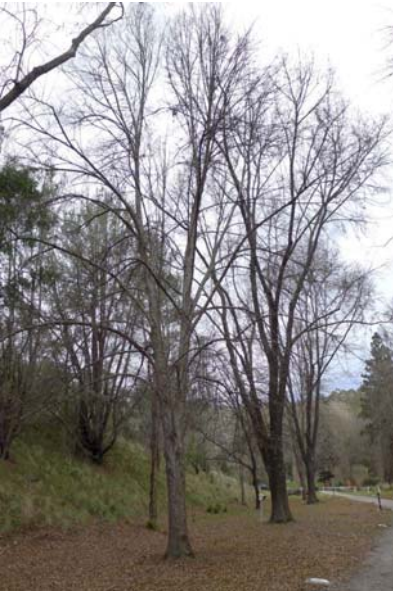
Image 1 from north-west: Tree 570

Comments: Stem is within excavation area, [JH 2022: N/A] TPZ Encroach: 59%. SRZ Encroached?: Yes

Assessment: Lost

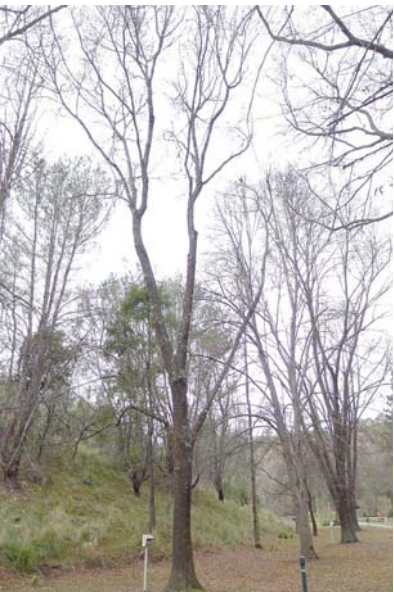
Image 1 from north-west: Tree 571

Comments: Surface roots to1.6m of stem on east side. Stem within excavation area, [JH 2022: N/A] TPZ Encroach: 58%. SRZ Encroached?: Yes

Assessment: Lost

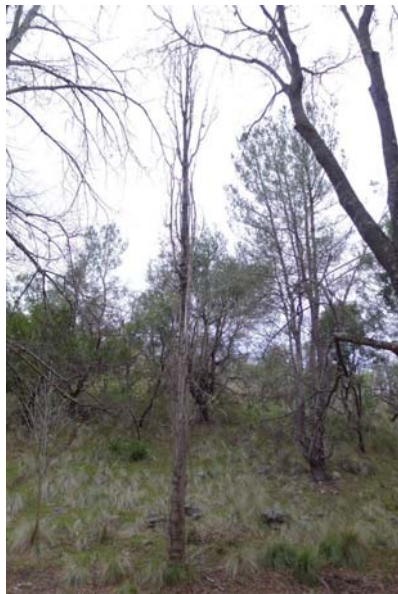
Image 1 from west: Tree 572

Comments: Stem is within excavation area, [JH 2022: Remove] TPZ Encroach: 48%. SRZ Encroached?: Yes

Assessment: Lost

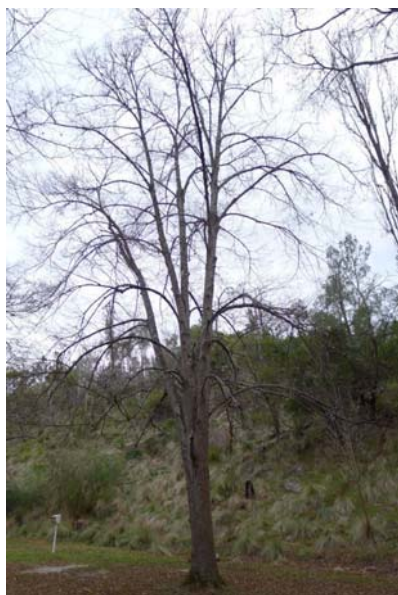
Image 1 from south-west: Tree 574

Comments: Stem within excavation area, [JH 2022: N/A] TPZ Encroach: 55%. SRZ Encroached?: Yes

Assessment: Lost

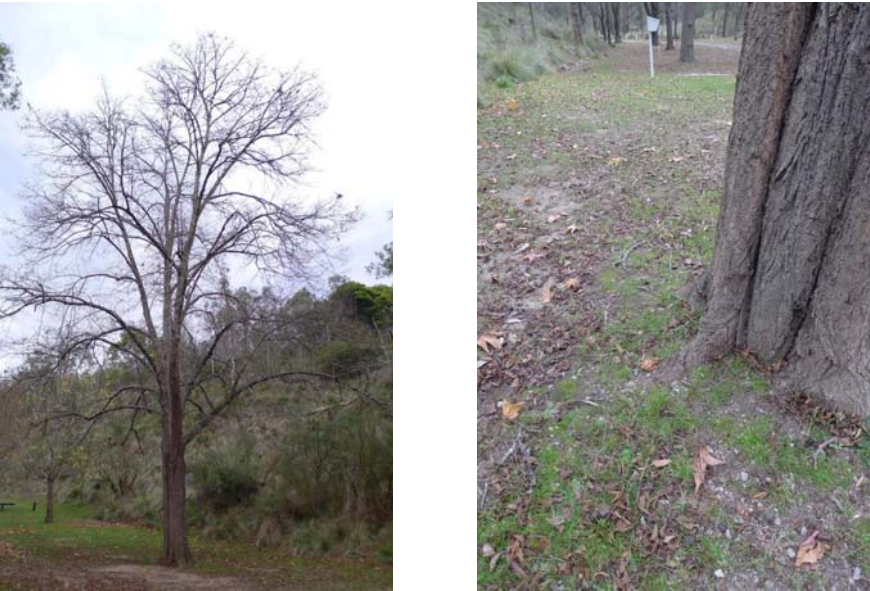
Image 1 from south-west: Tree 575

Comments: Stem is within excavation area, [JH 2022: N/A] TPZ Encroach: 45%. SRZ Encroached?: Yes

Assessment: Lost

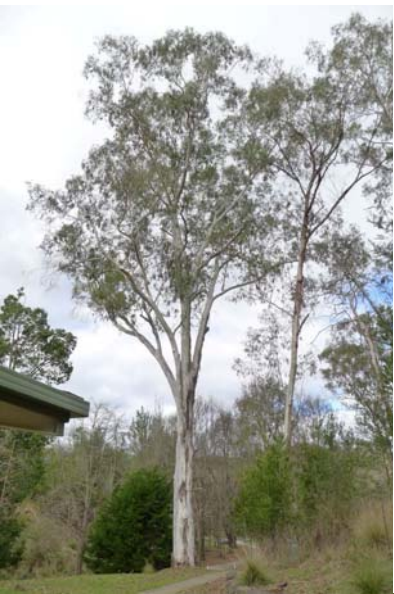
Image 1 from north-west: Tree 580

Defects: Recent major branch failures on north side

Comments: Species identification required, no fruit or buds found (possibly *E.mannifera*), [JH 2022: N/A] TPZ Encroach: 0%. SRZ Encroached?: No

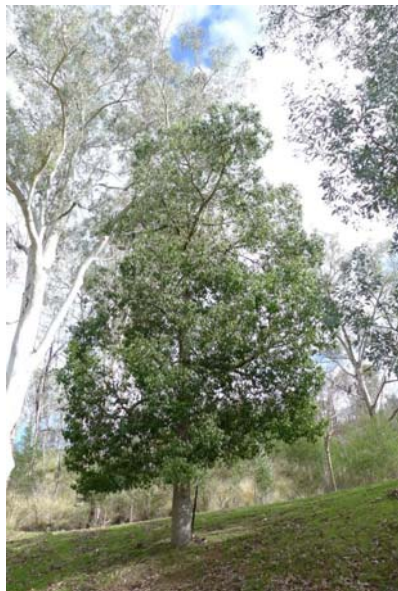
Image 1 from east: Tree 581

Comments: Remove stake before it becomes embedded in stem, [JH 2022: N/A] TPZ Encroach: 0%. SRZ Encroached?: No

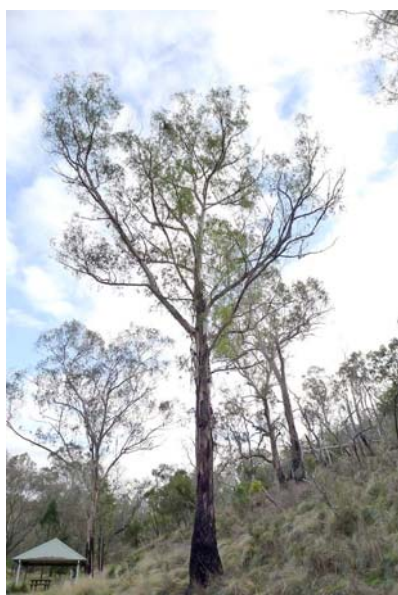
Image 1 from south: Tree 594

Defects: Fire damage

Comments: Fire damaged. Health appears to be recovering following fire. Species is possibly *E. rubida*, Surface roots to 3.4m of stem centre, Stormwater permitted to flow across the ground (comprising road and grassed area) to avoid swale in TPZ [JH 2022: N/A] TPZ Encroach: 0%. SRZ Encroached?: No

Assessment: Minor impact

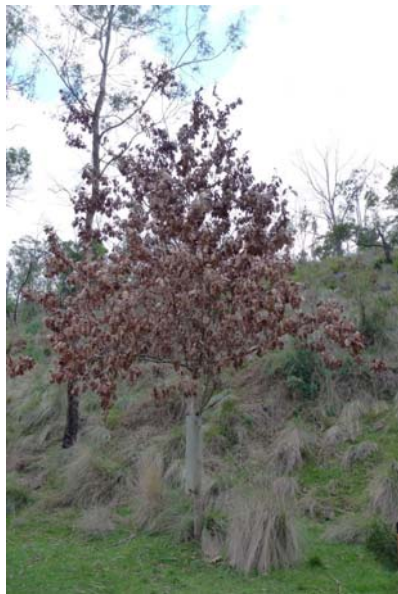
Image 1 from south-west: Tree 595

Defects: Minor or none noticed

Comments: Stem within excavation, [JH 2022: N/A] TPZ Encroach: 78%. SRZ Encroached?: Yes

Assessment: Lost

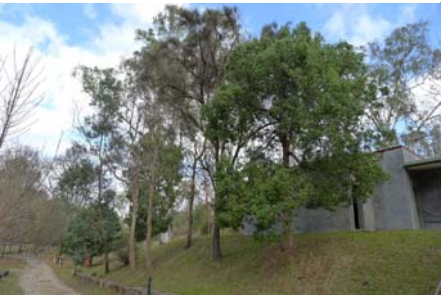
Image 1 from north-east: Tree 602

Defects: Minor or none noticed

Comments: Below HV powerlines may be a maintenance issue in future, [JH 2022: Remove] TPZ Encroach: 0%. SRZ Encroached?: No

Assessment: No impact

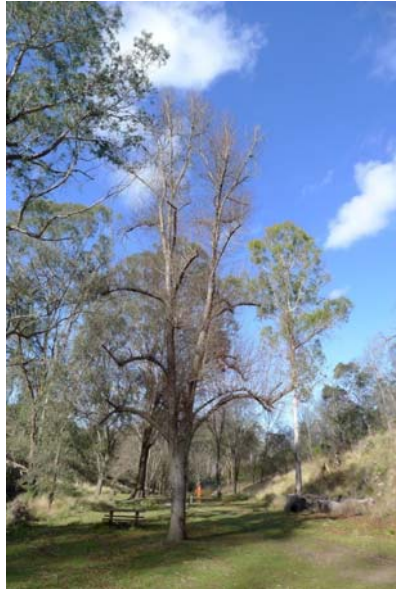
Image 1 from north: Tree 609

Defects: Lesions of dieback longitudinally along many branches

Comments: Tree has been reduced using reduction cuts possibly due to past dieback, Appears to be recovering health, [JH 2022: N/A] TPZ Encroach: 0%. SRZ Encroached?: No

Assessment: No impact

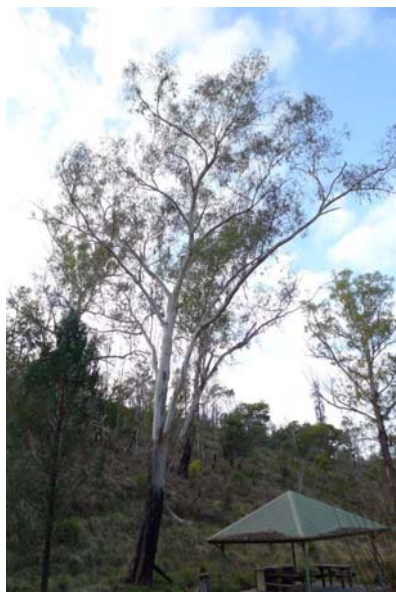
Image 1 from north-west: Tree 623

Defects: Fire damage, Root plate heave on north east side

Comments: Stability test for root plate movement carried out by ArbKey, Stormwater permitted to flow across the ground (comprising road and grassed area) to avoid swale in TPZ, [JH 2022: N/A] TPZ Encroach: 0%. SRZ Encroached?: No

Assessment: Minor impact

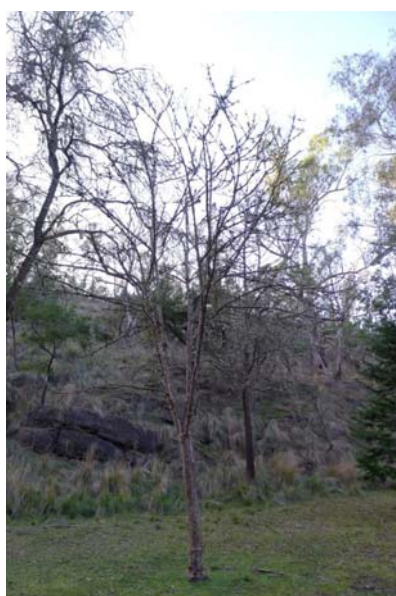
Image 1 from west: Tree 625

Defects: Minor or none noticed

Comments: [JH 2022: N/A] TPZ Encroach: 0%. SRZ Encroached?: No

Assessment: No impact

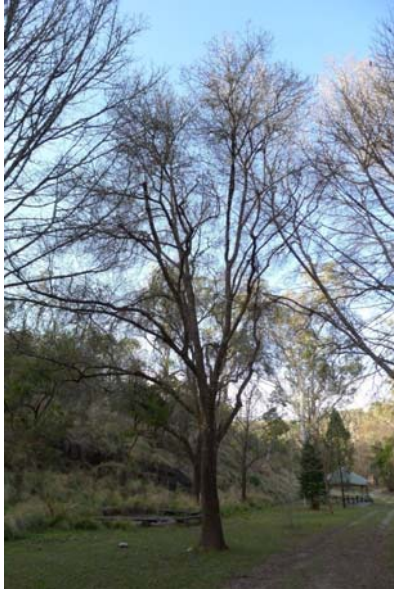
Image 1 from north-west: Tree 627

Defects: Minor or none noticed

Comments: Tree may possibly be saved with careful work overseen by arborist[JH 2022: N/A] TPZ Encroach: 22%. SRZ Encroached?: No

Assessment: Moderate to high impact

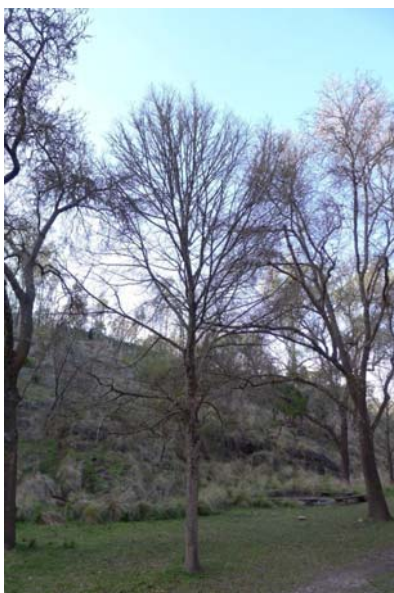
Image 1 from north-west: Tree 628

Defects: Minor or none noticed

Comments: [JH 2022: N/A] TPZ Encroach: 0%. SRZ Encroached?: No

Assessment: No impact

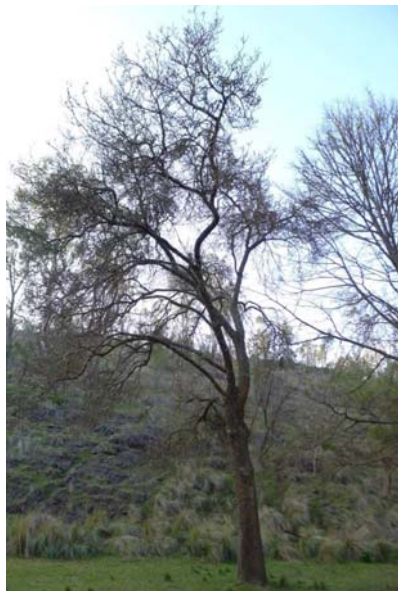
Image 1 from north-west: Tree 629

Defects: Minor or none noticed

Comments: Stem is within excavation area, [JH 2022: N/A] TPZ Encroach: 56%. SRZ Encroached?: Yes

Assessment: Lost

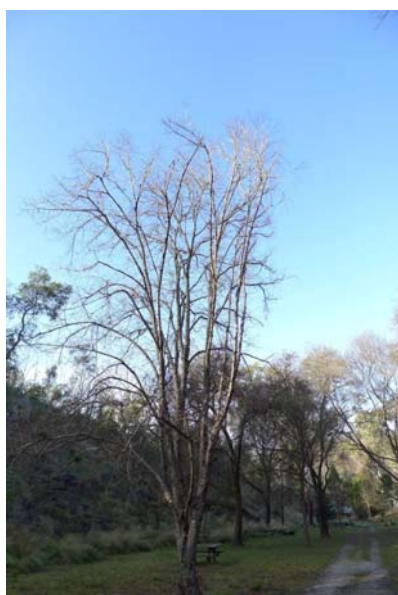
Image 1 from north-west: Tree 630

Defects: Bifurcation defects of stem

Comments: [JH 2022: N/A] TPZ Encroach: 9%. SRZ Encroached?: No

Assessment: Minor impact

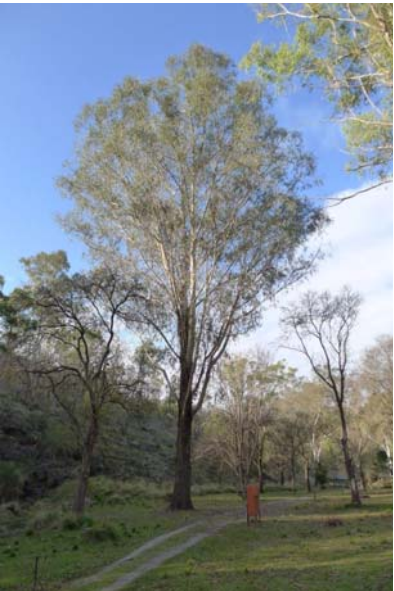
Image 1 from north-west: Tree 632

Defects: Minor or none noticed

Comments: Retain: Very High retention value tree, [JH 2022: Remove and replace with Eucalyptus viminalis (Error in tree number. 632 is a large Manna Gum S. Fitzgerald)] TPZ Encroach: 9%. SRZ Encroached?: No

Assessment: Minor impact

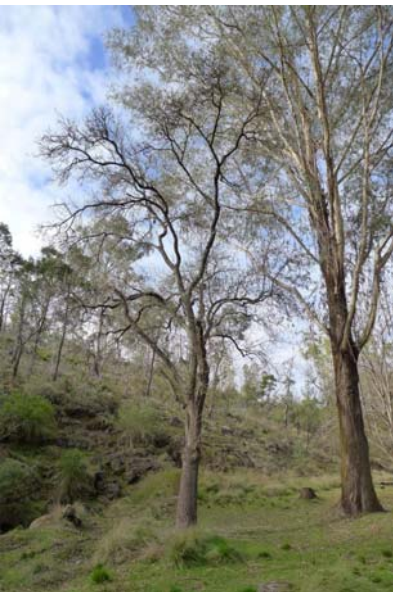
Image 1 from north-west: Tree 633

Defects: General decline of structure

Comments: Appears to be in decline, [JH 2022: Remove], Reasons for tree removal (2023): Declining health TPZ Encroach: 0%. SRZ Encroached?: No

Assessment: No impact
